Manhole Inspection Summary

Manhole # S25I__072MH

Insp Date: **3/18/08 10:32 AM**

Location Address: **1035 BOYD ST.**

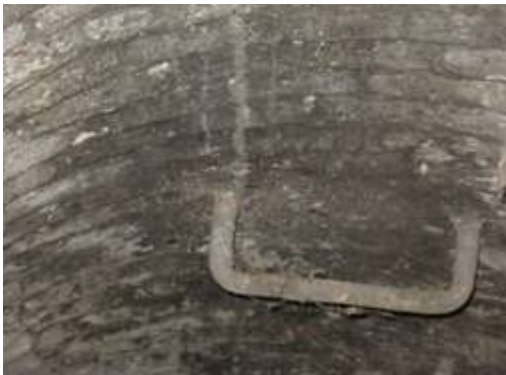
Defect 5

Infiltration: ☐ None ☐ Joint ☐ Cracks ☐ Mortar ☐ Roots ☒ **Wall**

EVIDENCE OF CORBEL INFILTRATION

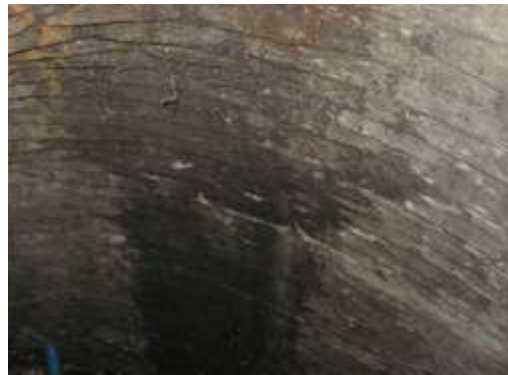
Defect 4

EVIDENCE OF INFILTRATION FRM CORBEL TO BARREL

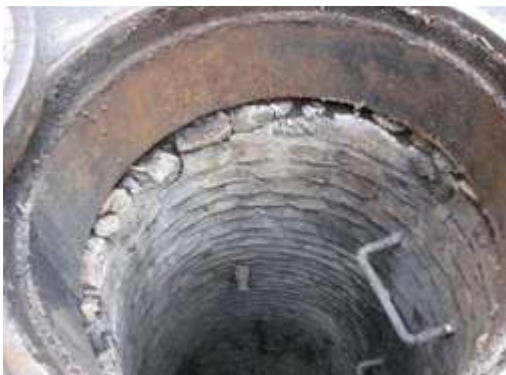
Defect 3

Condition: ☐ Sound ☒ **Cracked** ☐ Root Intrusion ☒ **Loose Brick** ☐ Deteriorated

MISSING MORTAR AND LOOSE BRICKS AT CHIMNEY

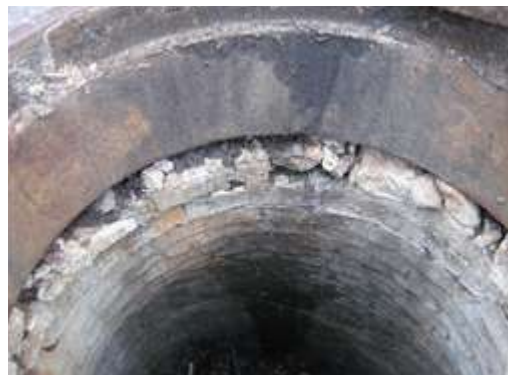
Defect 2

Infiltration: ☐ None ☐ Joint ☒ **Cracks** ☒ **Mortar** ☐ Roots ☐ Wall

MISSING MORTAR AND BRICKS WITH EVIDENCE OF INFILTRATION AT CHIMNEY AND INFILTRATION AT

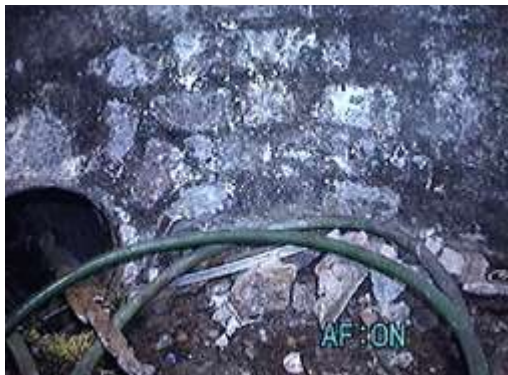
Defect 1

Comments **Heavy debris deposits in channel and in the pipe.**

Infiltration: ☐ None ☐ Joint ☐ Cracks ☐ Mortar ☐ Roots ☒ **Wall**

Condition: ☐ Sound ☐ Cracked ☐ Root Intrusion ☐ Deteriorated ☐ Leaks ☒ **Debris**

EVIDENCE OF BARREL INFILTRATION;
channel debris

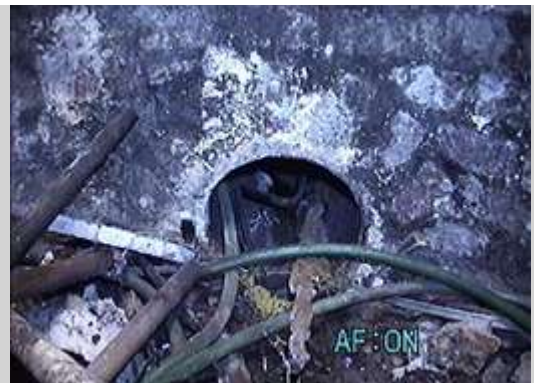
12 O'Clock Outflow

8 in. Circular Gravity Sewer
Pipe Out @ 12 O'Clock

Infiltration: **None** Pipe Seal Cond: **Sound**
